Case Study

Project: FCC Environment Millerhill Valve Replacement

Scope of Work: Replacement of the 24" ARCA Actuator Valve and associated pipework.

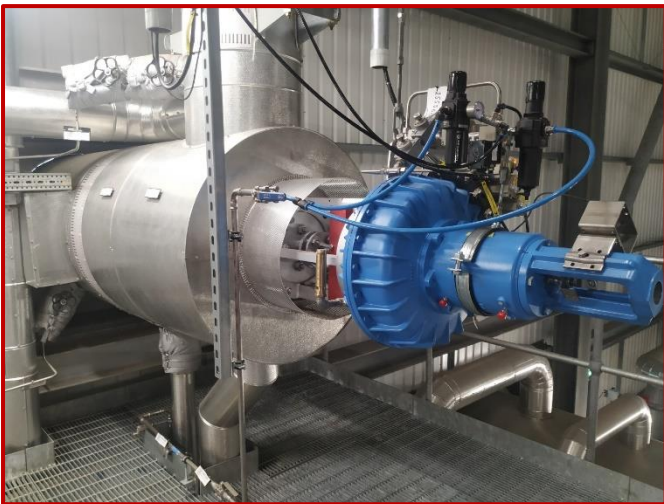
Description: Due to the original actuator valve 'passing'* our client elected to replace the defective valve. The client order was placed on 21st October 2019 with works scheduled to commence on 28th October.

Existing Defective Actuator Valve

- Erection of access scaffolding
- Removal of insulation
- Gagging of Pipework to prevent movement
- Removal and replacement of valve under OEM supervision
- Welding of valve
- Pre and post weld heat treatment
- NDT

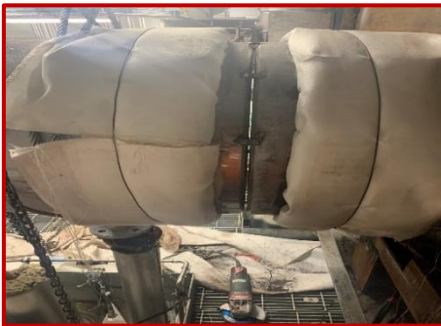
Fit-up of 24" Weldment

- 1 x 24" (609.6mm OD x 12.5mm wt.) Butt weld of 16Mo3 Valve weldment material to P11 existing Pipework material which required Pre & Post weld heat treatment to the main 24" joint together with 100% Volumetric UT + MPI testing carried out to the completed weld
- 1 x 6" (168.3mm OD x 8mm wt.) Butt weld 16Mo3 Valve weldment to existing 16Mo3 pipework. 100% Volumetric RT + MPI testing carried out to the completed weld
- 1½" – 1" (48.3mm-33.4mm x 3.2mm wt.) concentric reducer Butt welds 16Mo3 Valve to existing 1" 16Mo3 pipework. 100% Volumetric RT + DPI testing to the completed welds
- 4 x 1½ (48.3mm x 3.2mm wt.) Butt welds to modified associated 16Mo3 pipework. 100% Volumetric RT + DPI testing to completed welds

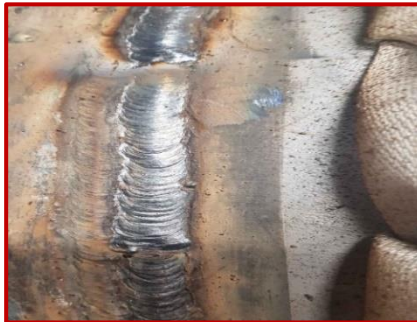
24" Root Run

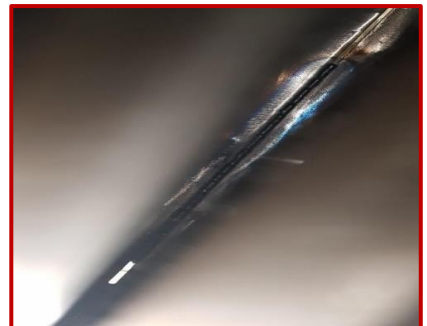
Visual Inspection of Cap

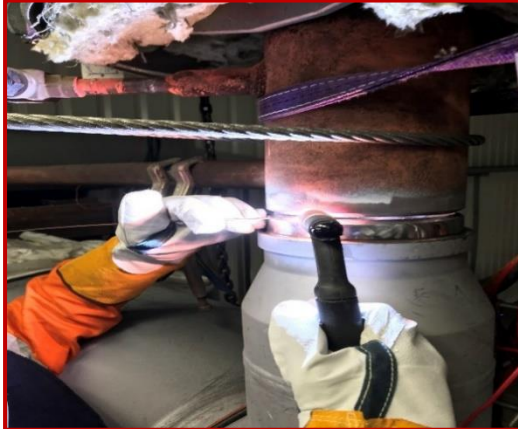
Inspection of 24" Root Run & Cap

- All welds achieved 100% pass for both Visual and Volumetric testing
- Full scope achieved within the specified timeframes including emergent works modifying existing pipework

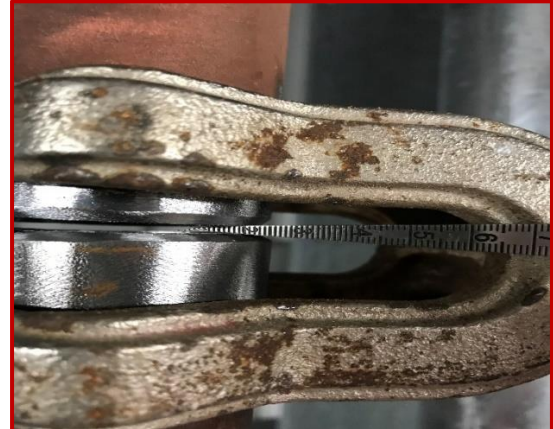
6" Welding & Fit-up of associated pipework
