Case Study

Project: **Sembcorp Nitrogen Cavity Makeover (Work Pack 1)**

Scope of Work: Installation and testing of Valves and Pipework into an existing piping system.

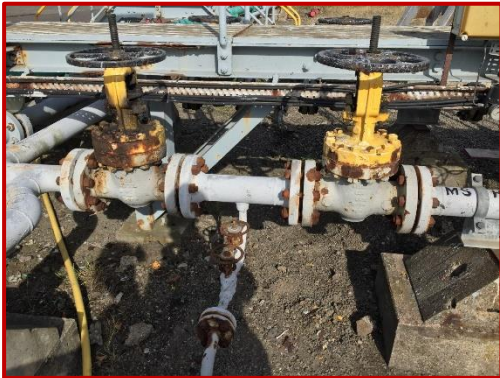
Existing Defective Valves & Bobbin

Description: All defective valves including 12 sets of double block and bleed valves together with the associated pipework was replaced during the Nitrogen System Outage. A comprehensive list of existing flanges was required to be broken, inspected, cleaned and where necessary repaired prior to being re-jointed with new gaskets/bolts and torqued to the correct settings. Working to exacting standards the number of Non-Pressure Tested Closure welds was to be kept to a minimum and where unavoidable the 'golden' welds were subject to ultrasonic and radiographic inspection.

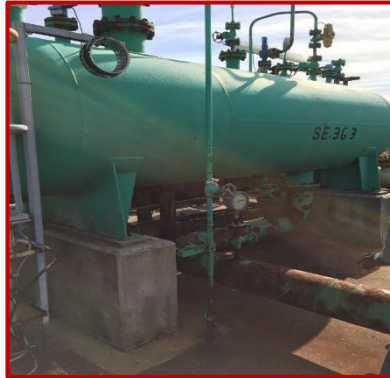
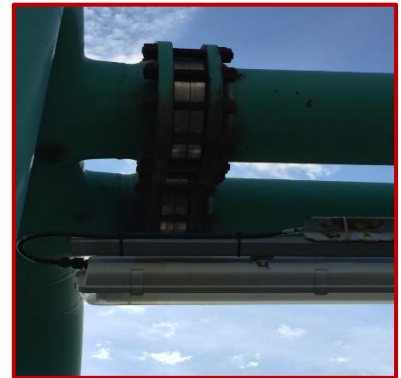
Various Flanges for Inspection/Re-jointing

A total of 105 various size Flanges were broken, inspected and rejoined and 94 welds completed consisting of:
