Case Study

Project: **Wilton 10 Wall Tube Replacement with Inconel Clad Panels**

Scope of Work: Constructability study, detail design, procurement, manufacture, installation and NDT testing of 96 number water wall panels measuring 8 tubes X 6 metres and 7 tubes X 6 metres.

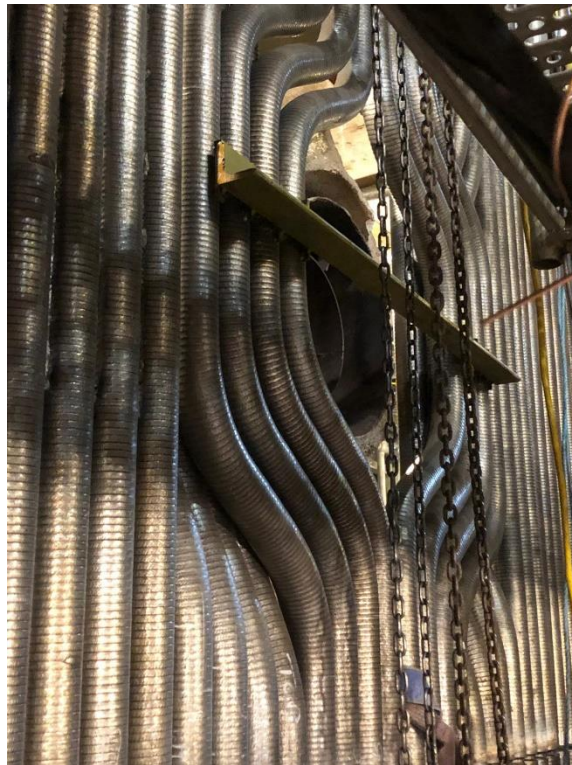
A fully designed internal boiler scaffold was erected using the ATPAC propriety system. The scaffold had to accommodate the flashing in of the 6 metre panels. The initial cut was made on the South West corner on May 1st. Working in a heavily congested environment the 2 shifts of 26 tradesmen worked simultaneously on all 4 walls in pursuit of the 20 day timescale which would see the boiler handed back to Sembcorp water and gas tight and ready for pressure testing on May 21st. Each shift had a full time Site Manager, Site Engineer and QA Superintendent, and a single Project Planner worked an overlap shift. Scaffold Mod Squads were allocated to each shift to cater for the constant modifications required to facilitate the movement of panels and the final in-situ butt welding of the panel fins.

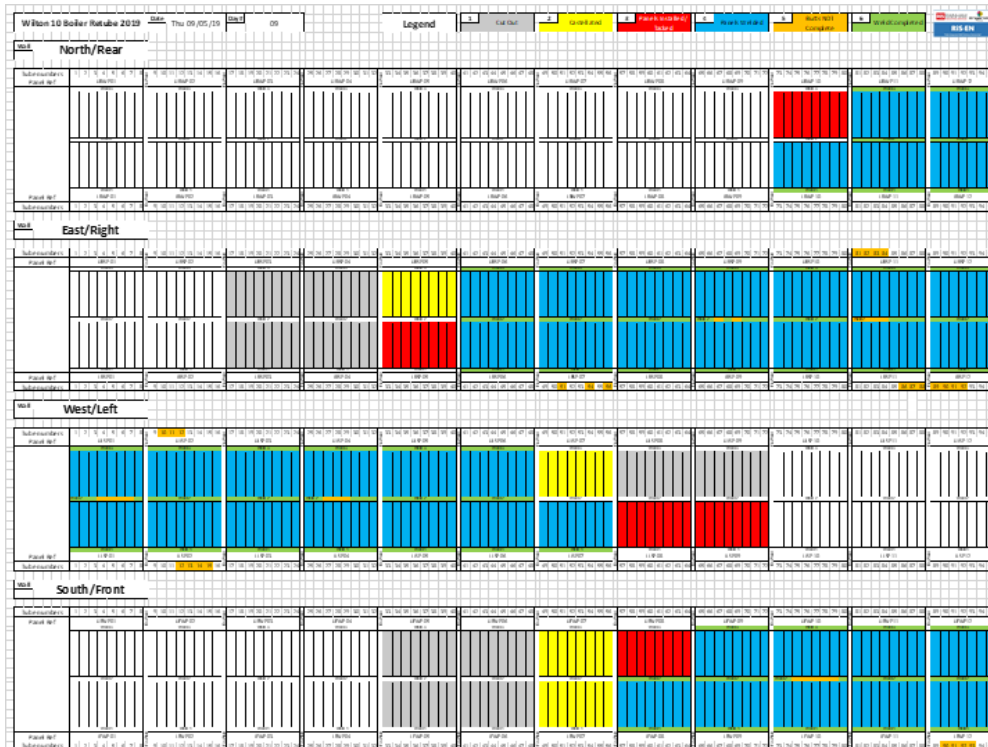
Progress

Our Project Planner updated Sembcorp on progress at every shift change using a simple graphic which instantly conveyed progress on each wall and predicted end date and time.
